# Evaluación de un puente en Ensenada, Provincia de Buenos Aires, Argentina

## Assessment of a bridge in Ensenada, Buenos Aires Province, Argentina

V. G. Rosato LEMaC, La Plata, vrosato@frlp.utn.edu.ar  
L. P. Traversa LEMIT, La Plata, Buenos Aires, Argentina, direccion@yahoo.com.ar  
F. H. Iloro  
R. A. García  
J. D. Sota GIIICMA -UTN Universidad Tecnológica Nacional -Facultad Regional Concordia, Concordia, E.R., ARGENTINA -jdsota@gmail.com

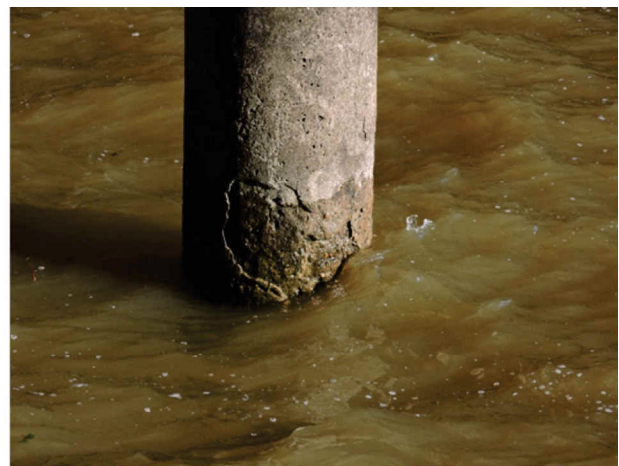
Columns and beams do not show fissures, although there is evidence of weathering in the submerged part of the columns (Figure 2).

**Figure 2.** Detail of a column.

There are orange-red stained patches under the concrete slabs, but no cracks or fissures. The columns have lost material from the superficial layer. This is attributed to a mechanical action of the water, because the chemical analysis proved it has almost inexistent amounts of potentially aggressive substances. However, the mentioned loss did not cause a significant reduction of the columns' section.

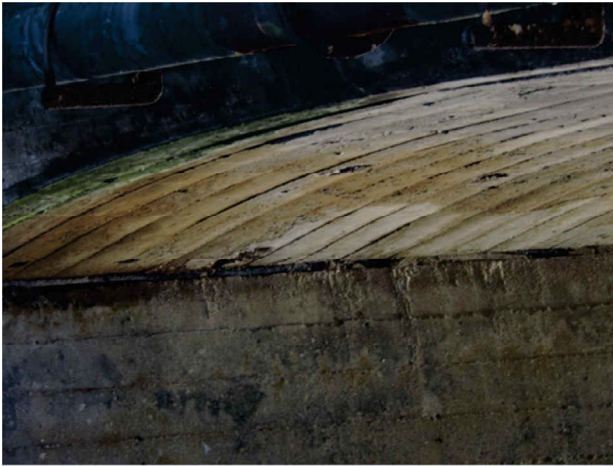
There is also evidence of corrosion of the metal bars, but no damage caused by the expansion of the iron oxides (Figure 3); there is no material loss or exposed metal bars. The concrete slabs and the asphalt pavement have no important cracks or fissures that could endanger the structure.

**Figure 3.** Detail of the orange staining cause by metal oxides.

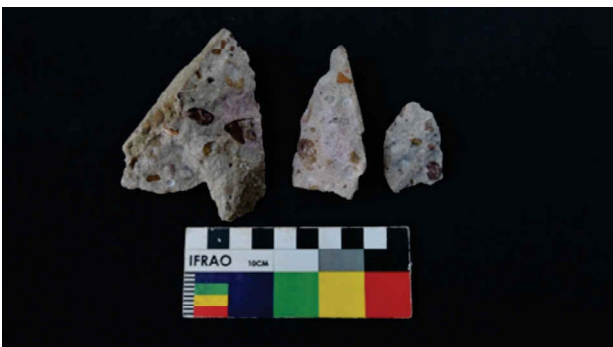
According to the performed tests, mortar is almost carbonated: the outer layers are non reactive and carbonated, whereas the rest of the material inside only has a slight reaction to phenolphthaleine, (Figure 4)

**Figure 4.** Mortar samples, tested with phenolphthaleine (on the right, non- tested piece as blank). Note the faint pink reaction.

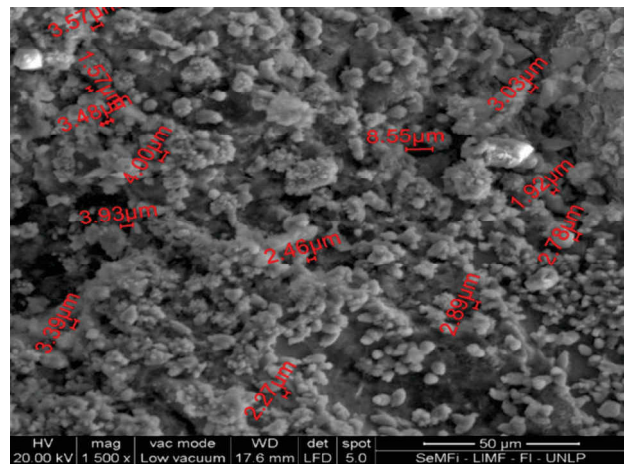
**Figure 5.** Pore measurements of the mortar observed at 1500 X.

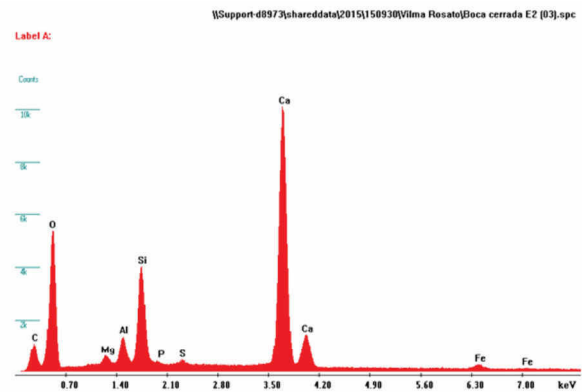
Electron Dispersive Spectrometry (EDS) results indicate that the cement mortar still has a good calcium proportion (Table 1), which can also be noticed in the spectrum (Figure 6).

**Figure 6.** EDS Spectrum of a mortar sampl.

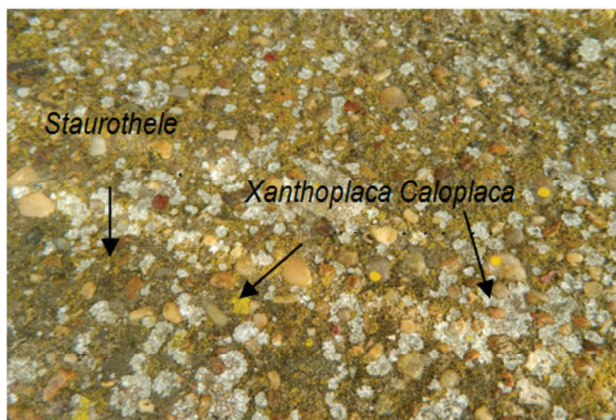
The only organisms observed were lichens (Figure 7): *Xanthoplaea austrocitrina*, *Caloplaca teicholyta* and *Staurothele monosporoides*, three species commonly found on mortars in Buenos Aires Province (Rosato & Garcia, 2014). There are no ferns or plants.

Figure 7. Detail of a column.
